APOLLO 16 MISSION

ANOMALY REPORT NO. 11

MALFUNCTION OF TELEVISION CAMERA MONITOR
ON COMMAND MODULE

MANNED SPACECRAFT CENTER
HOUSTON, TEXAS
OCTOBER 1972

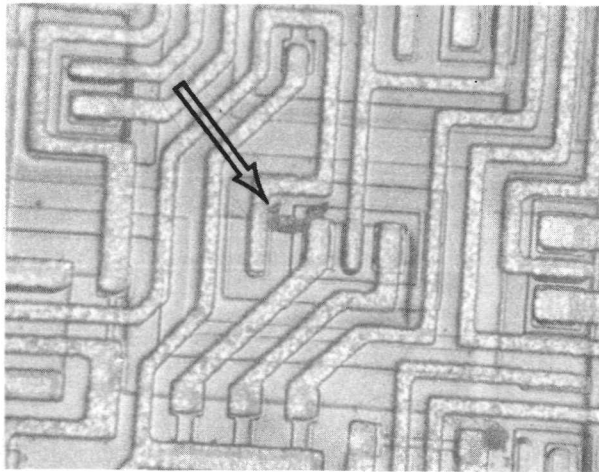
The problem was isolated to the precision voltage regulator which is a linear integrated circuit. The circuit assembly was removed and opened for inspection. It had the following defects:

1. There was general contamination and scoring on the chip face (fig. 1a).
2. Multiple attempts had been made in welding leads to the bonding posts and bonding pads on the chip (fig. 1b).
3. The lead on bonding post number 1 was loose (fig. 1c). As a result, the current sensing loop of the voltage regulator was open and the output ripple increased sufficiently to desynchronize the horizontal hold circuit.

(a) Contamination and scoring on chip face.

The precision voltage regulator with the television monitor low voltage power supply on Apollo 16 will be replaced and the regulator on Apollo 17 has been replaced. The replaced components will be opened, inspected, and tested.

2. The low-voltage power supply precision voltage regulator (linear integrated circuits) will be replaced on the seven remaining unmodified flight units.

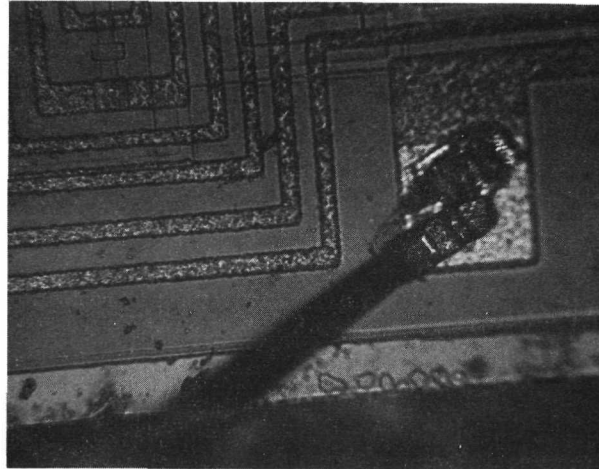
(b) Evidence of multiple attempts to weld lead to bonding pad.

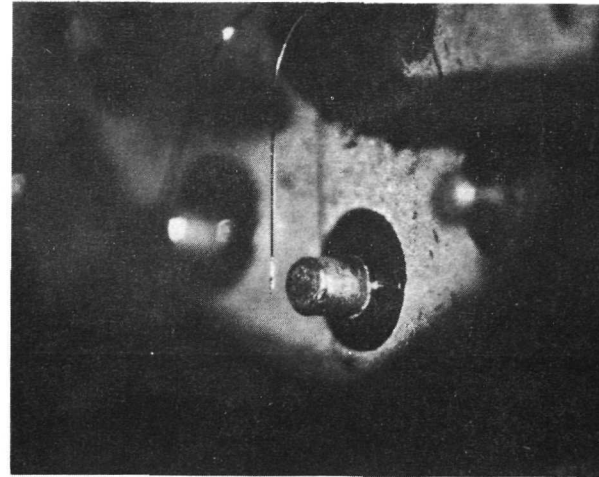
The loss of horizontal synchronization was most likely caused by either an intermittent condition in the precision voltage regulator circuit assembly in the low voltage power supply, or the shift of the stable range of the horizontal potentiometer setting when warming up after turn-on.

(c) Loose lead on bonding post.
